# **Harding University**

## **University Student Launch Initiative**

**Final Report**  
**May 25, 2007**

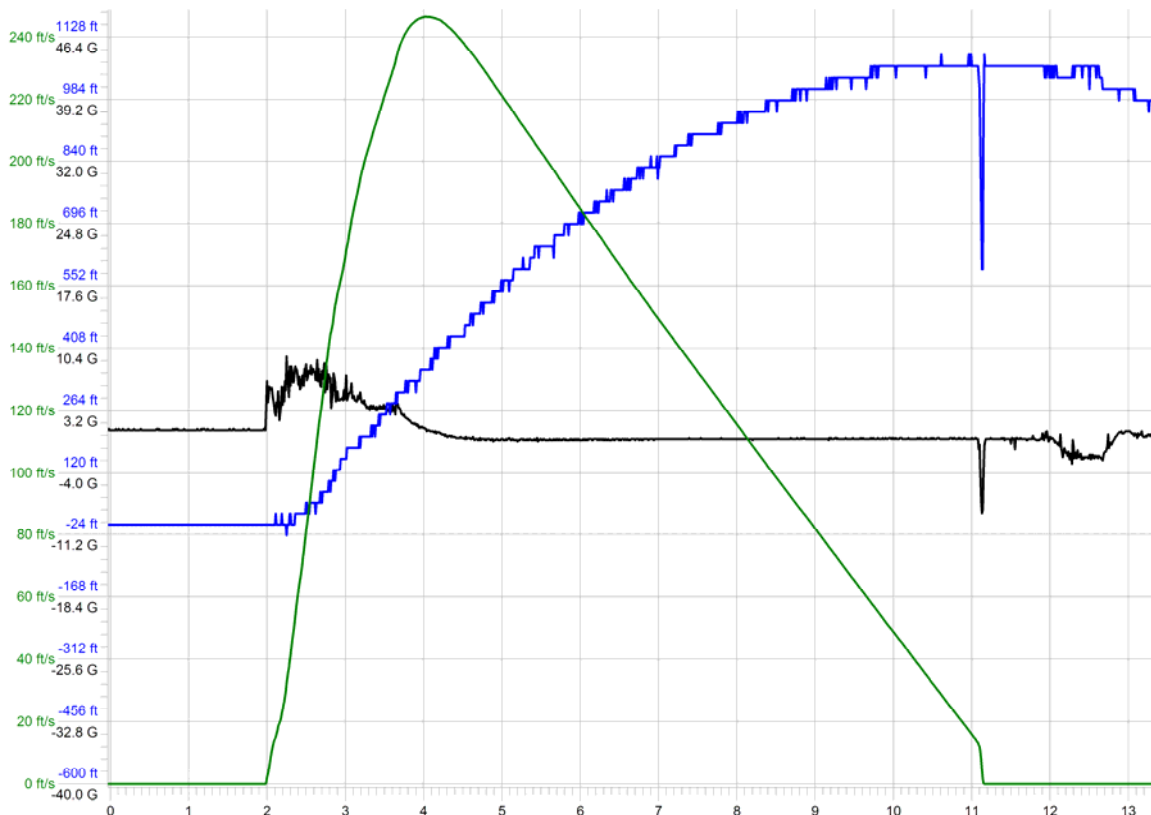
The R-DAS unit provided a reported altitude of 1088 feet. The velocity, acceleration, and altitude were all obtained and graphed as follows, with green being velocity, blue being altitude, and black being acceleration:

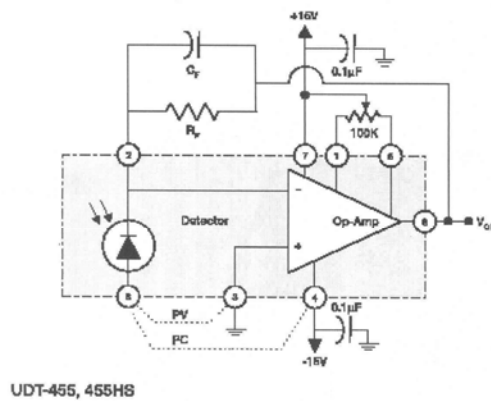
**Figure 1.** UDT-455HS Diode.

The sensor used as our science package was a UDT-455HS diode with a built-in amplifier as shown in Figure 1.

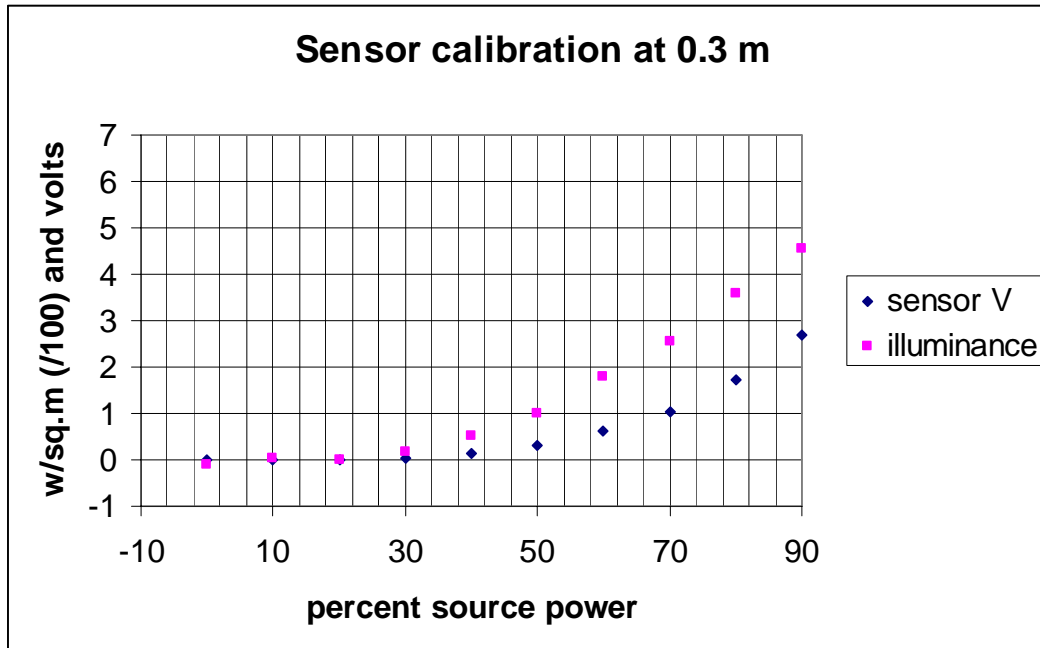
**Figure 2.** Sensor Calibration onboard rocket at 0.3m.

A retest of the sensor assembly, in situ on the rocket, showed that it was functioning correctly and could be properly calibrated, as can be seen on the graphs attached to the next section of this report.
